## **2010 Annual Inspection Report**

### **Barataria Barrier Island Complex Project: Pelican Island and Pass La Mer to Chaland Pass Restoration**

State Project Number BA-38  
Priority Project List 11

August 31, 2011  
Plaquemines Parrish

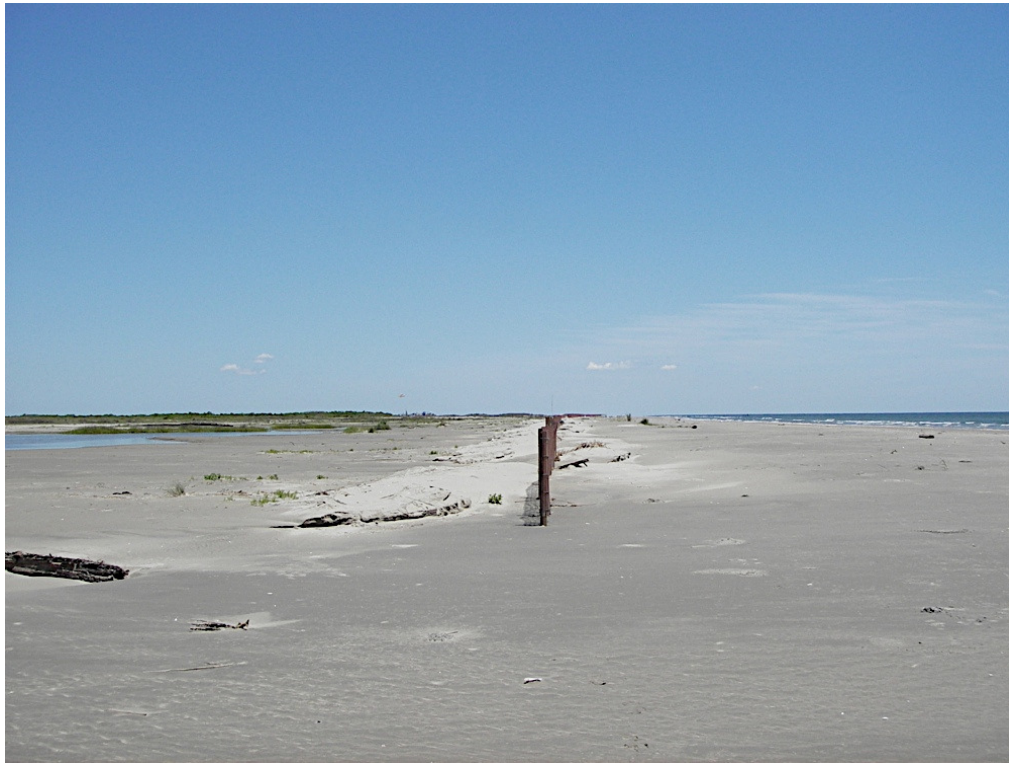
The new sand fencing is in good condition and is performing very well. There is evidence of sand accumulation at the base of the fence. (Photo #1)

**Photo #1 –New Sand Fencing (BIMP).**

It is the recommendation of the OCPR/NOFO that the sand fencing and vegetative plantings be replaced as necessary. This is complete as of the date on this report.

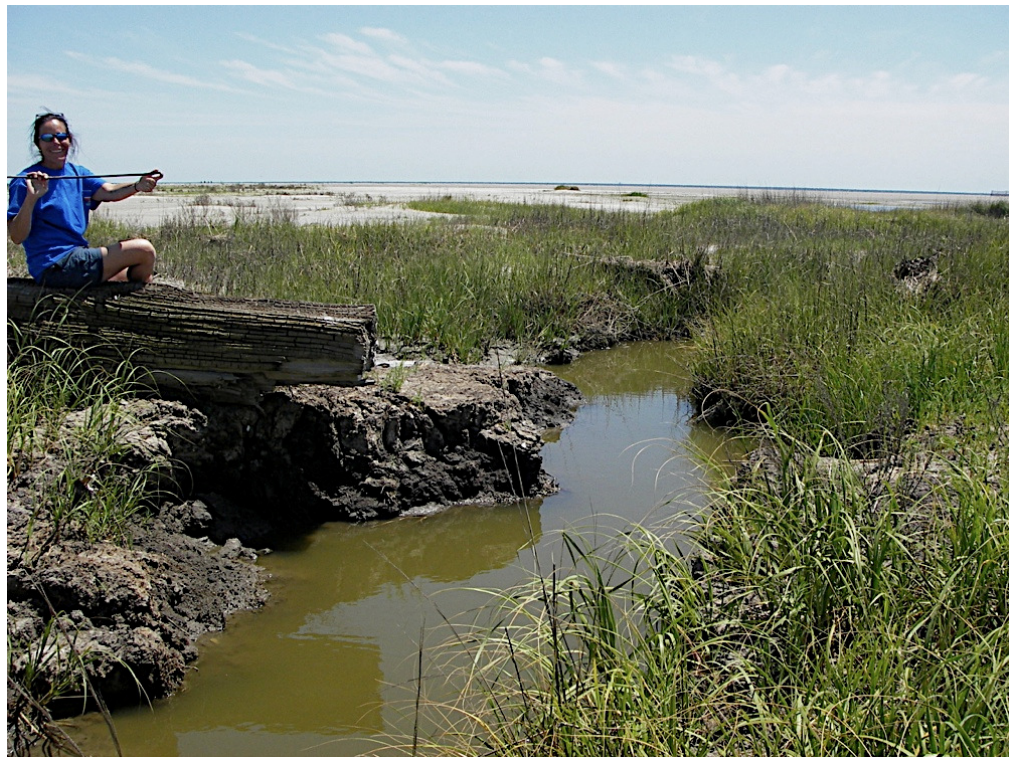
The containment dike was not degraded upon demobilization from the construction site. During the period between demobilization and this inspection the dike has been slowly degrading due to natural processes. In May, 2008, members of the OCPR and NMFS hydraulically cut 4 gaps into the containment dike using a high pressure pump. After Hurricanes Gustav and Ike two of these gaps had become filled in with sand. At the time of the inspection all four were open and flowing water. (Photo #2)

**Photo #2 – Western Dike Gap.**
